E.N. MANOS (CYPRUS) LTD  
SURVEYORS LOSS ADJUSTERS

**INTERIM REPORT No. 11358**

**SITUATION OF LOSS:** Latsia industrial area

**OCCURRENCE:** Fire

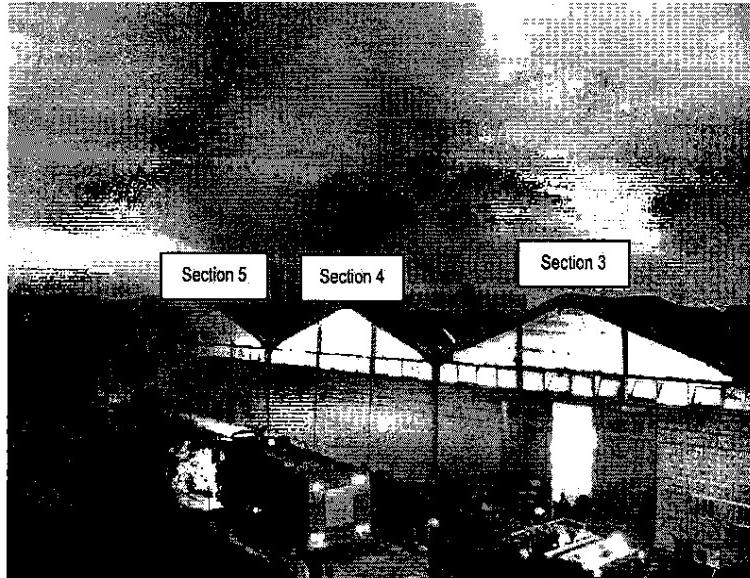
On the same afternoon the fire broke out, we were instructed by the Insurers to visit the site. The fire extinguishing efforts were in process (see Fig 3).

Figure 3 – Photo taken on the day of the loss
